Mirror Edge Creep: Info & FAQ's

What is Mirror Edge Creep?

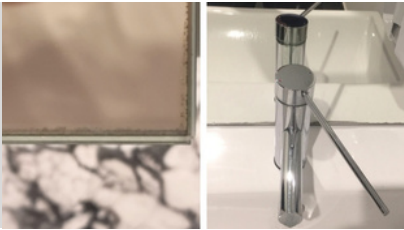
Mirror edge creep happens when the protective layers on the back of a mirror are compromised. This allows moisture and other environmental elements to reach the reflective silver coating, causing it to oxidise and lose its shine.

- **Moisture Exposure:** In kitchens, bathrooms, and laundries, steam and water splashes are unavoidable. Moisture can seep in and cause the silver backing to oxidise, leading to edge creep.

- **Improper Cleaning Methods:** Spraying cleaning solutions directly onto a splashback can cause liquids to run down and pool at the edges, penetrating the protective layers. To avoid this, always spray the cleaner onto a cloth first before wiping the surface.

- **Poor Installation Techniques:** Using adhesives with acidic components can compromise the mirror's protective layers.
- **Poor Quality Components in Manufacturing:** Mirrors made with low-quality silver, inadequate protective coatings, or subpar backing materials are more prone to edge creep. Cheaper manufacturing processes may cut corners on the protective layers, making the mirror more vulnerable to moisture and oxidation. Investing in high-quality, well constructed mirror splashbacks can significantly reduce the risk of edge creep.
